Effective collaboration for implant success

Marie Baldo discusses a referral to **Martin Wanendeya** for sinus graft and implant treatment

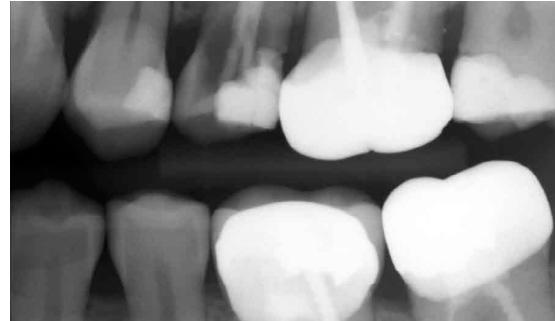
A nervous female patient presented with a UL5 cavity that required attention. During assessment, however, it was seen that UL6 also had a root fracture and had suffered significant subgingival damage, necessitating replacement (Figure 1).

Figure 1: Cavity on UL5 and root fracture on UL6

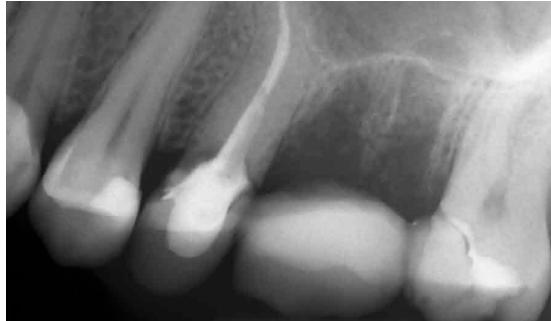
Martin extracted UL6 and the patient was provided with a provisional bridge using UL5 and UL7 to allow for healing (Figure 2). After six months the patient returned for

Figure 2: Provisional bridge on UL5 and UL7

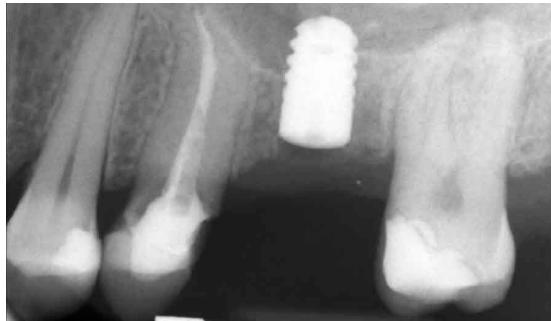
Figure 3: Orthopantomogram showing patient after six months' healing

assessment; healing had been particularly uneventful and the implant could be fitted with no further delay (Figure 3).

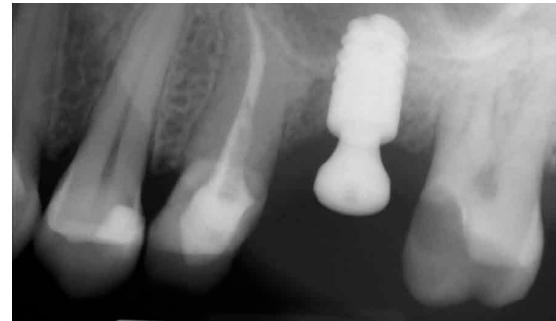
Figure 5: Implant with healing abutment in place

Healing was again uneventful and the sinus graft took suitably (Figure 5). The patient returned to me (Figure 6) and UL5 was filed to accommodate a crown while UL7 was prepared for the onlay (Figures 7 and 8). A closed tray impression was taken of the treatment site and sent to the lab.

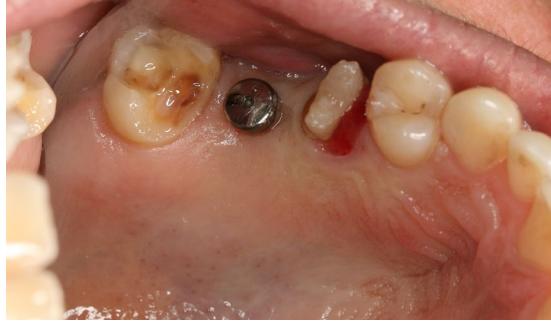
Figure 7: Preparation of UL5 and UL7

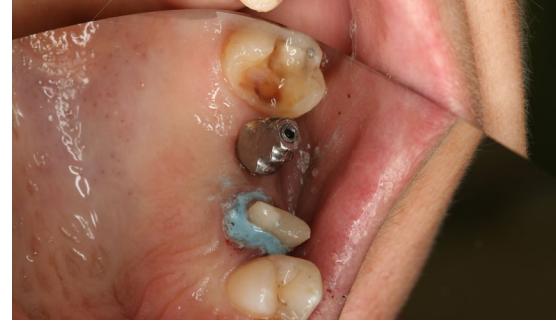
Figure 8: Tissue reattachment material around UL5

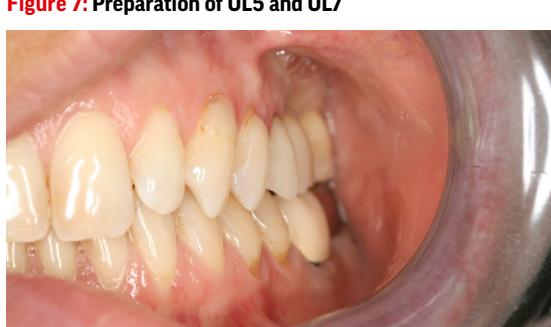
Figure 10: Final restoration in place

An E.max crown for UL5, screw-retained implant crown for UL6 and an E.max onlay for UL7 were created (Figure 9) and fitted (Figures 10 and 11). The result was exceptionally good, with a highly aesthetic finish, and the patient was very pleased with the outcome.

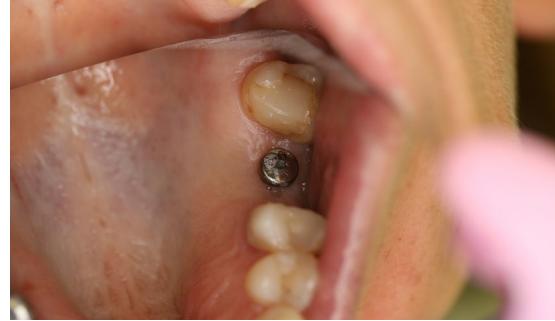
Figure 6: Implant with abutment after healing

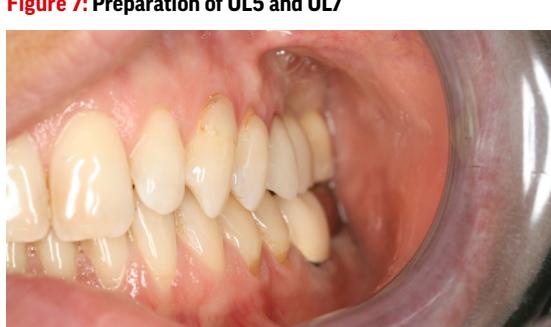
Figure 9: E.max crown, screw-retained implant crown and E.max onlay

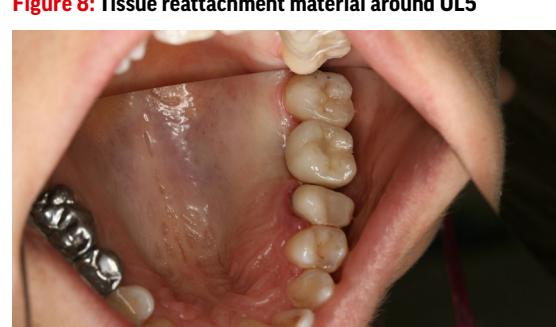
Figure 11: Final restoration in place
